# Tarbox Pond Dam

## Dam Assessment Report

West Greenwich, Rhode Island

Dam Name: **Tarbox Pond Dam**  
NID ID#: **RI 183**  
Owner: **State of Rhode Island**  
Town: **West Greenwich**  
Consultant: **Pare Corporation**  
Date of Report: **February 2024**

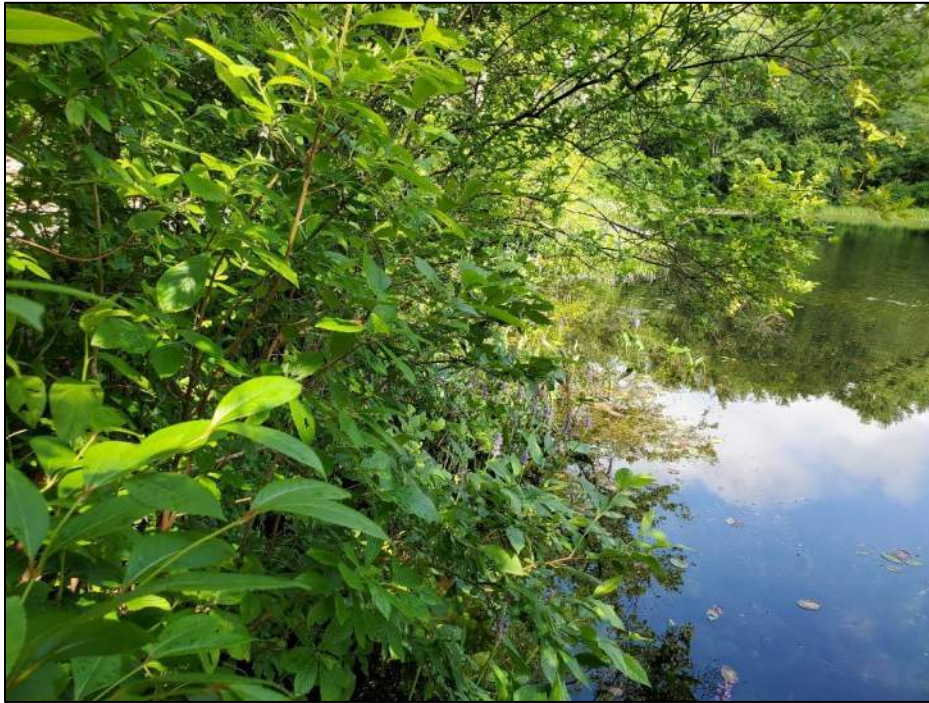
Photo No. 1. Upstream slope from STA 1+20 looking right. Note the dense woody vegetation growing on the upstream slope.

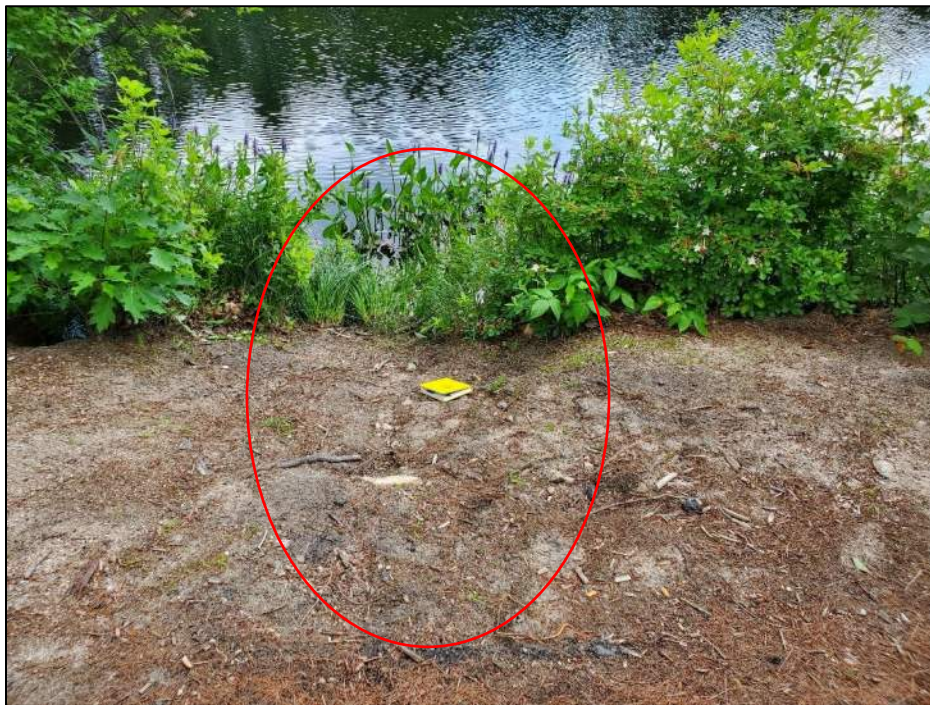
Photo No. 2. Upstream slope at STA 1+32. Note the erosion channel extending from Hopkins Hill Rd to Tarbox Pond (circle).

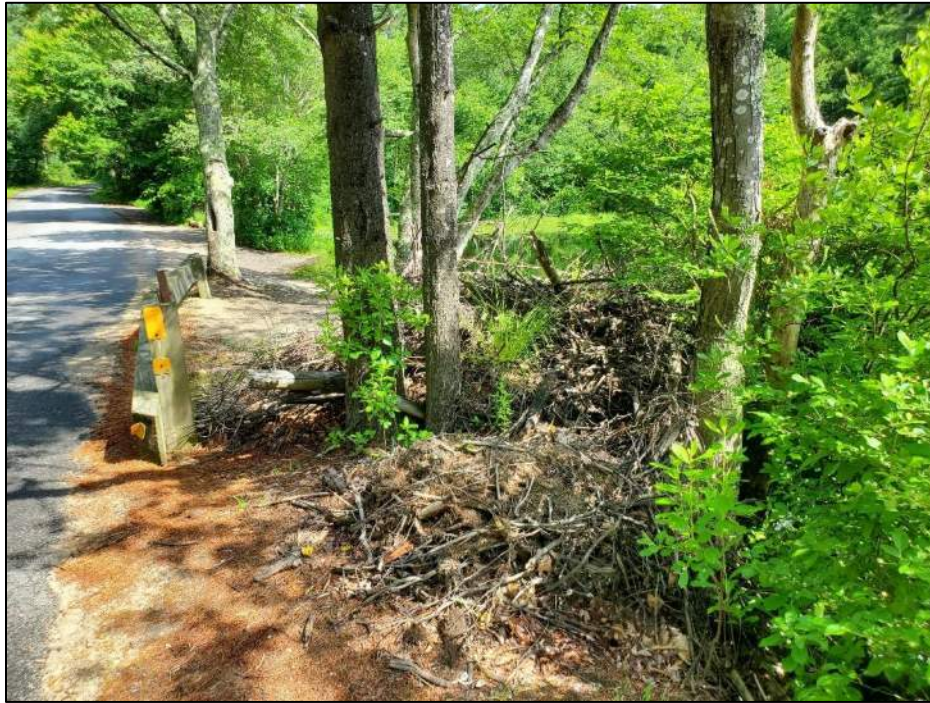
- Trees up to 16 inches in diameter were observed growing along the upstream slope between the spillway and the left abutment.
- An approximately 7' by 7' by 5' pile of dead tree branches and other beaver related debris was observed on the upstream slope at STA 1+30.

Photo No. 3. Upstream shoulder from STA 1+50 looking right. Note the trees up to 16 inches in diameter growing through the upstream slope and the pile of debris adjacent to the spillway.

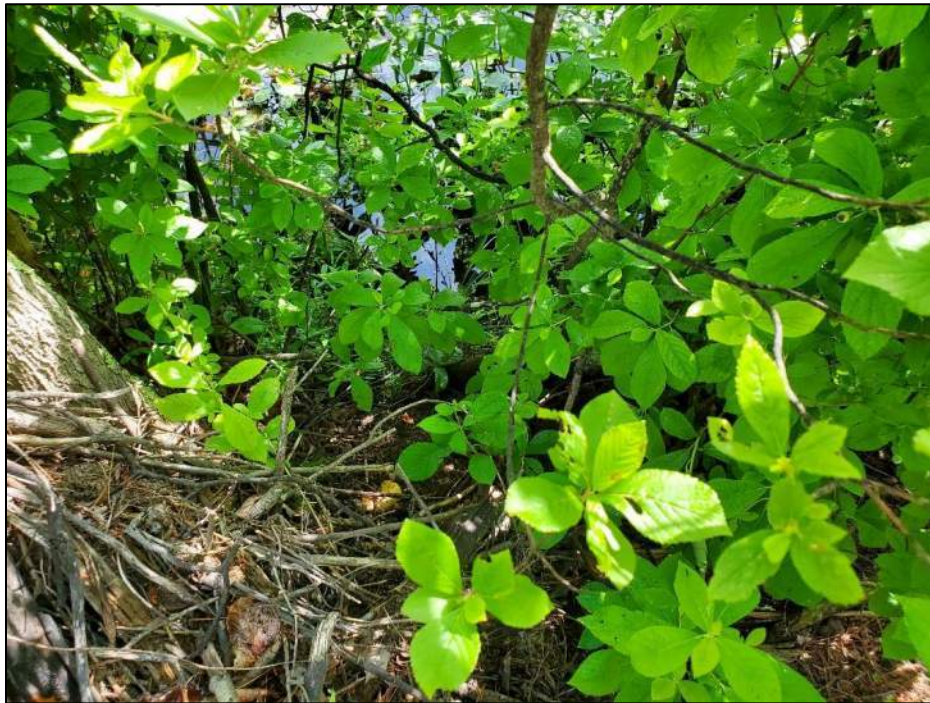
Photo No. 4. Upstream slope looking upstream at STA 1+50. Note the vertical scarping and dense woody vegetation.

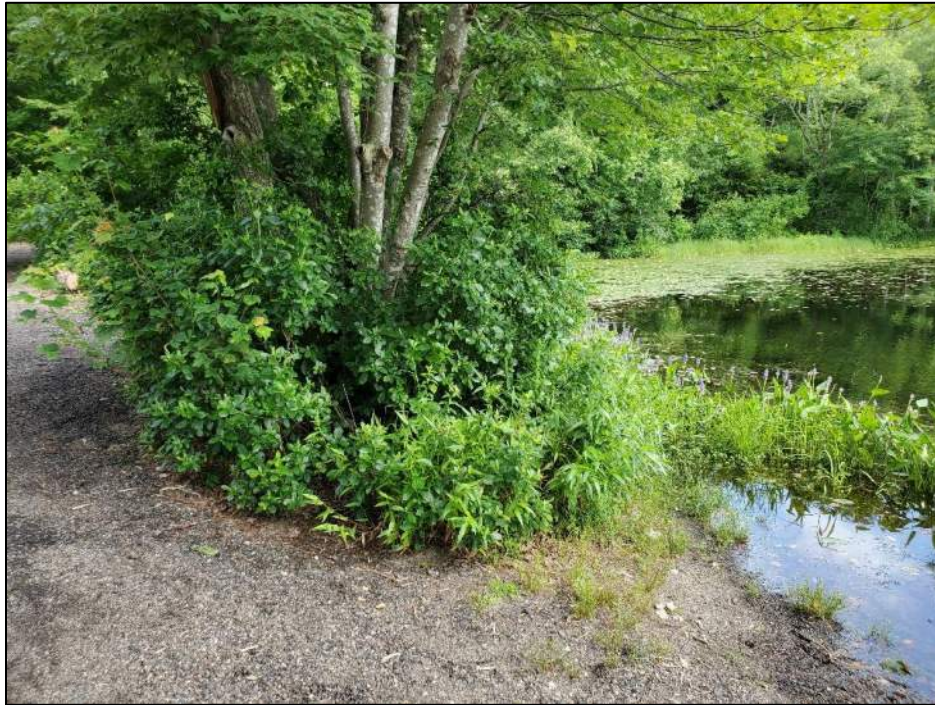
Photo No. 5. Upstream slope from STA 2+20 looking right. Note the trees up to 10 inches in diameter growing through the upstream slope.

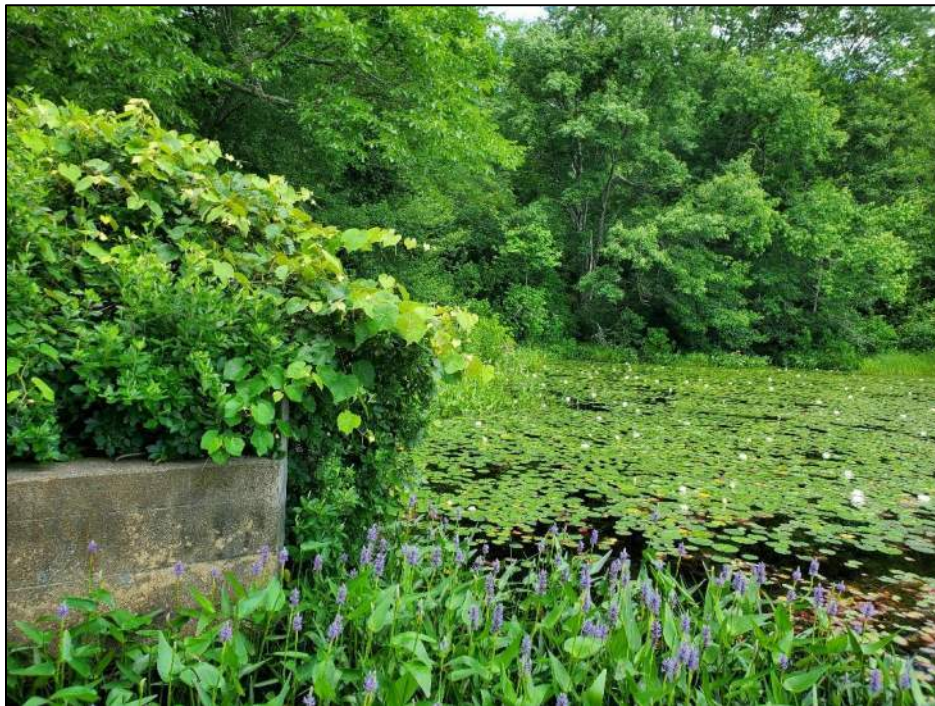
Photo No. 6. Upstream slope from STA 2+40 looking right. Note the historic LLO intake concrete headwall and the dense woody brush along the upstream slope.

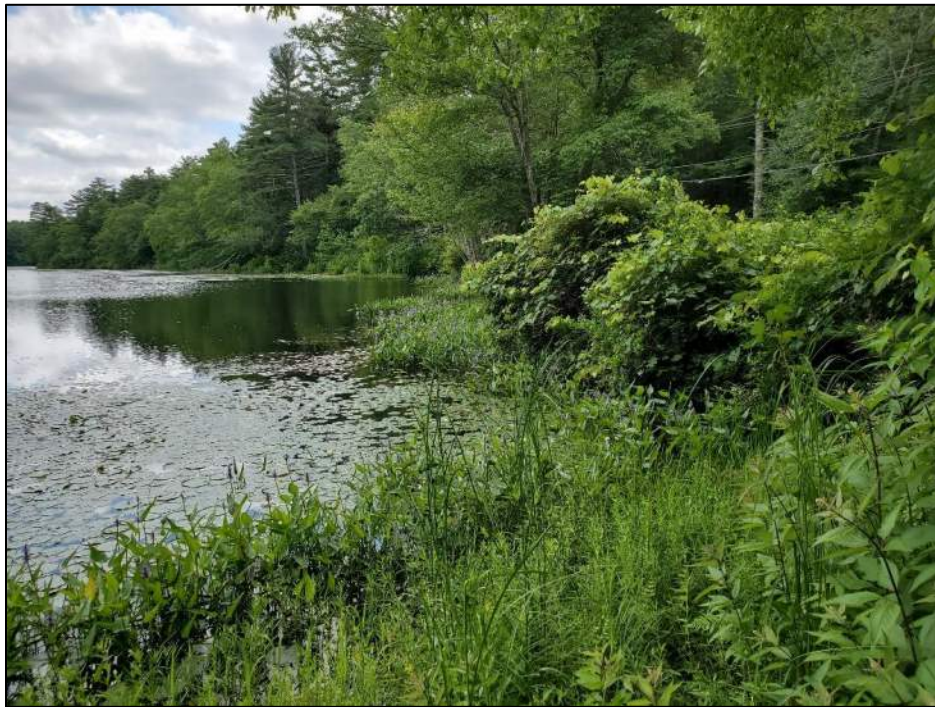
Photo No. 7. Upstream slope from STA 3+25 looking left. Note the dense woody brush and trees growing along the upstream slope.

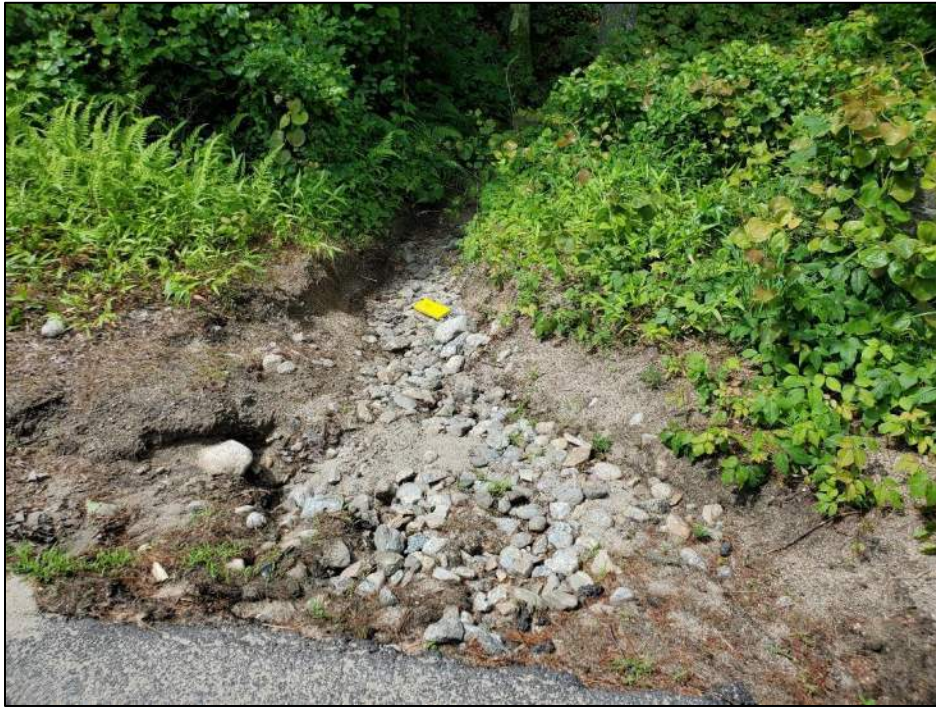
Photo No. 13. Downstream slope at STA 1+32. Note the erosion channel extending from Hopkins Hill Rd to Carr River.

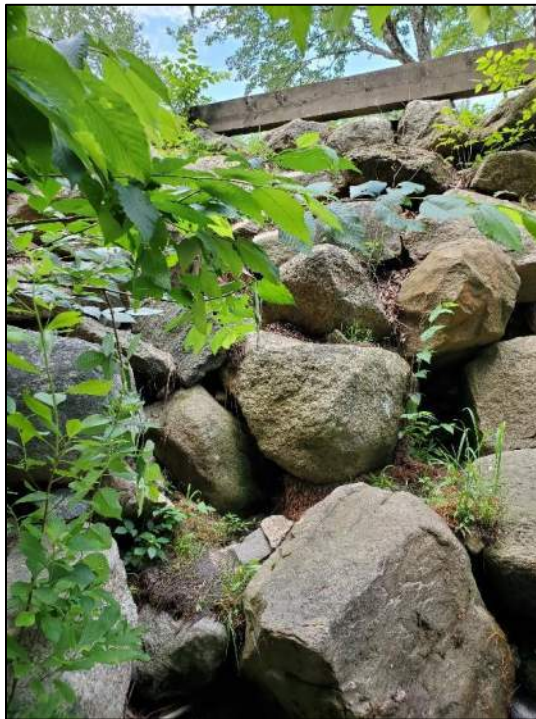
Photo No. 15. Downstream slope at STA 1+70 looking right. Note the large placed stones along the downstream slope.

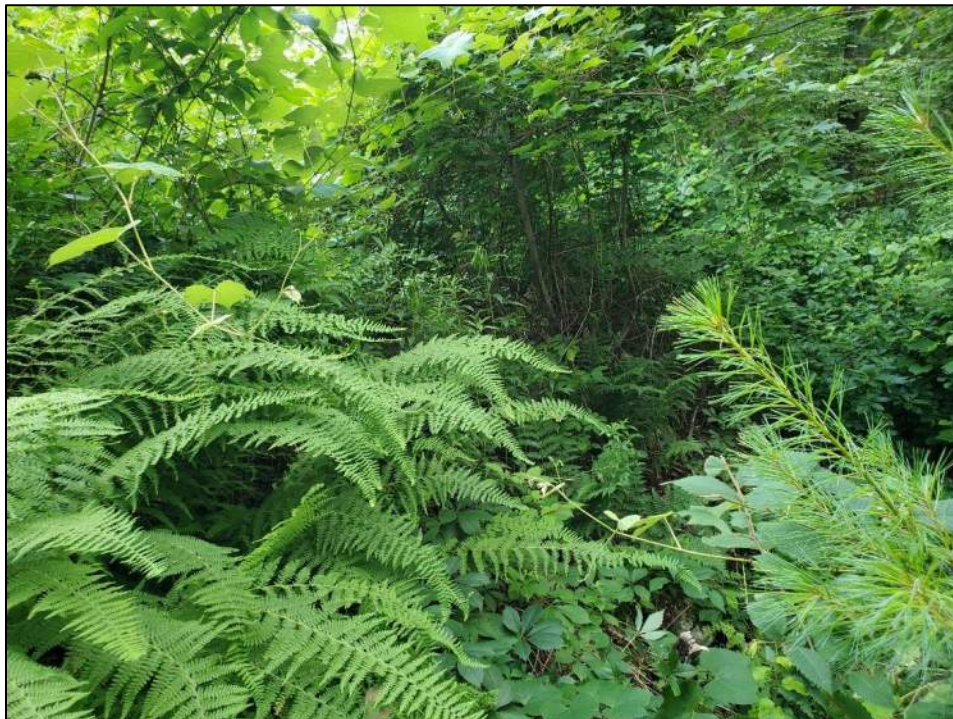
Photo No. 16. Downstream slope at STA 1+95 looking right. Note the dense vegetation and woody brush.

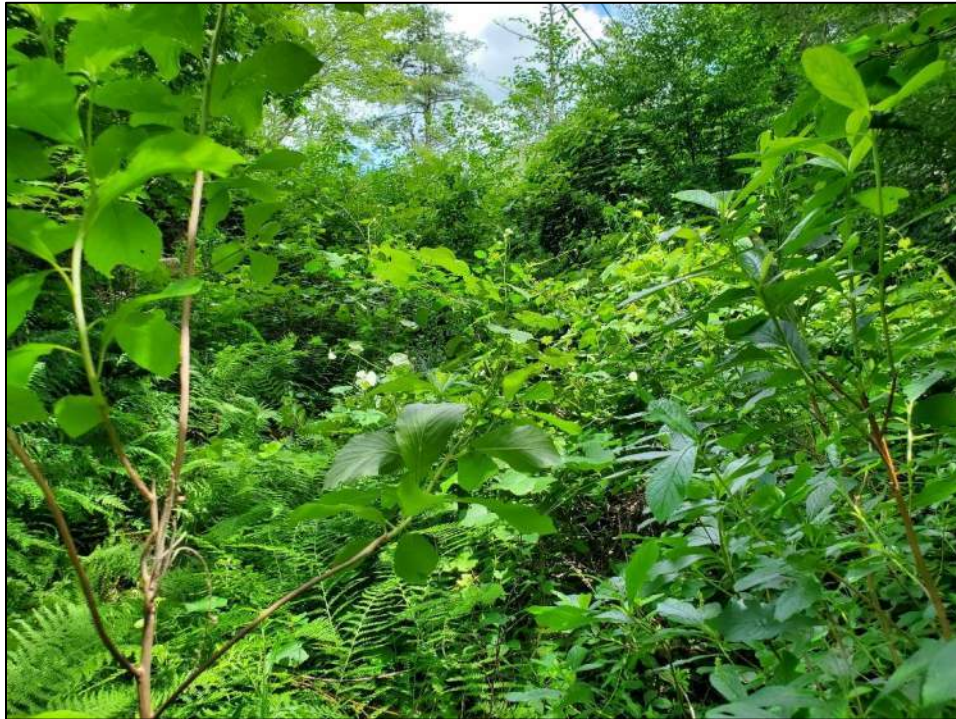
Photo No. 17. Downstream slope at STA 2+50 looking right. Note the dense vegetation and woody brush.

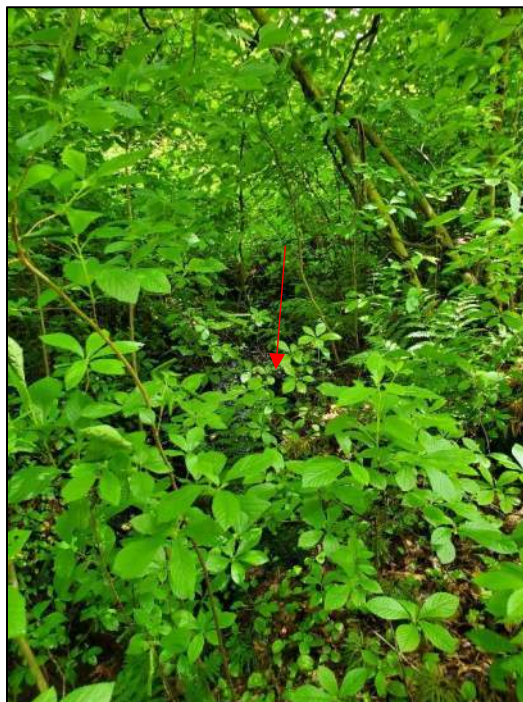
- A 2-foot wide by 1-foot-deep channel was present near the toe of the dam between STA 2+30 and 2+75. The ground within the channel was saturated and had iron flocculant staining. Standing water was present. Flow, estimated at less than 0.1 gpm was present at the point of confluence with the historic water supply outlet discharge channel, but no areas of concentrated flow were observed along the length of the channel.

Photo No. 18. Downstream slope at STA 2+75 looking downstream. Note the seepage channel (arrow).

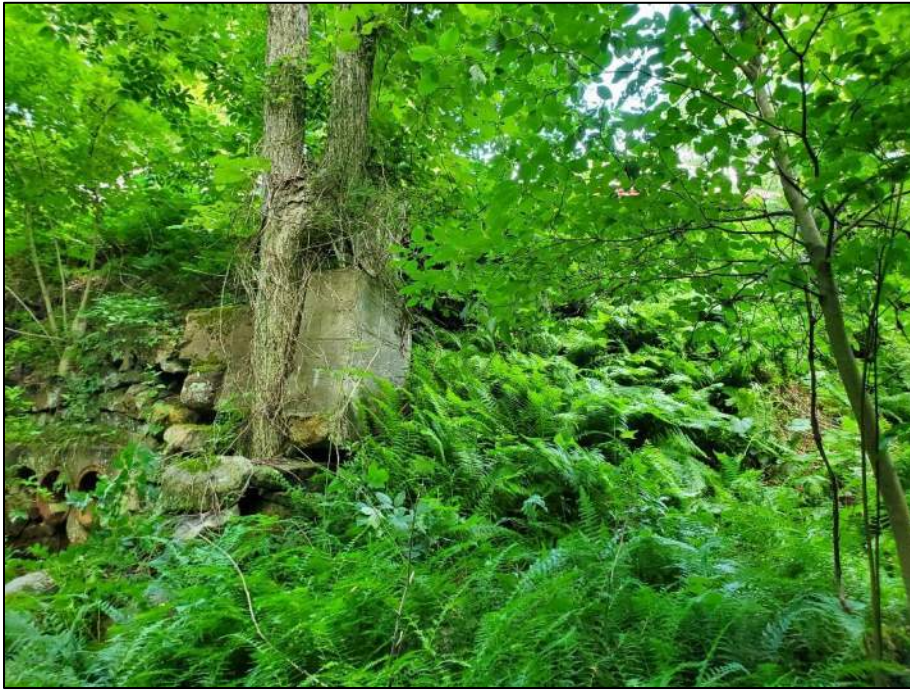
- The stone masonry appeared in poor condition with trees and woody vegetation growing through the masonry, displaced / missing stones, and signs of settlement.

Photo No. 19. Downstream slope at STA 1+75 looking upstream. Note the deterioration of the dry set stone masonry LLO outlet headwall and the tree growing through the headwall.

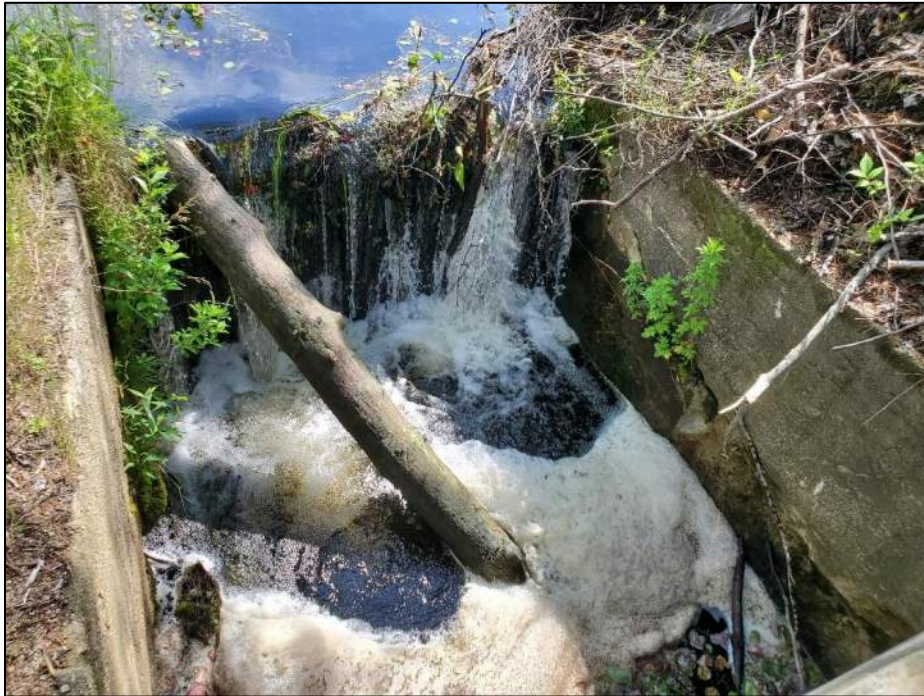
- The spillway weir was partially choked by dense vegetation growing up to the water surface.
- The stilling basin contained 1.55 feet of water at the time of the inspection, and dense vegetation within the basin was observed growing up to the water surface.

Photo No. 21. Spillway and stilling basin. Note the vegetation choking the spillway weir.

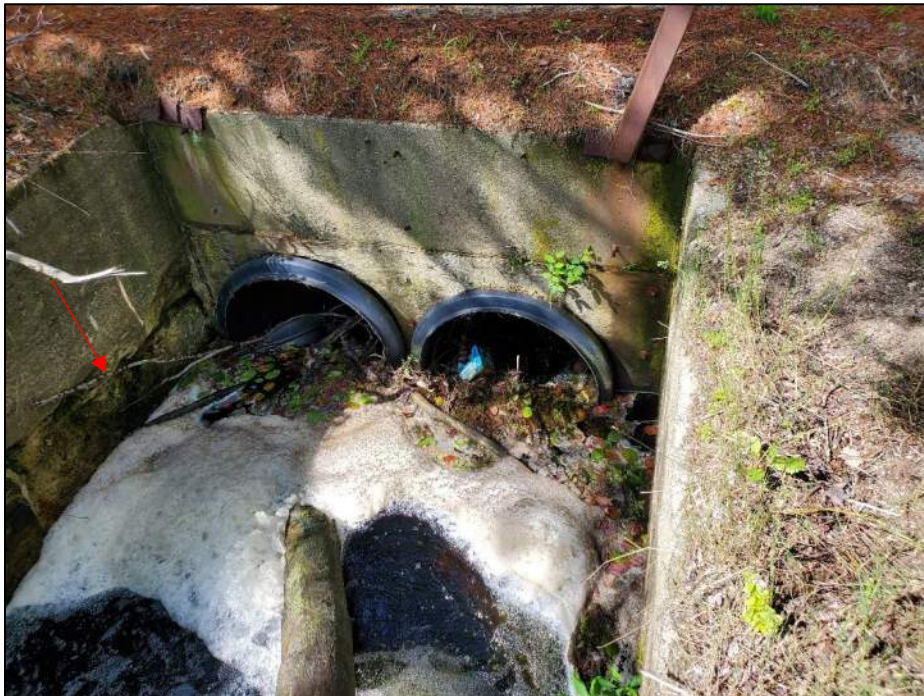
- The left concrete wall of the stilling basin contained a spall just above the waterline measuring approximately 1 foot wide, 3.5 feet long, and 4 inches deep.

- The two 3' diameter culverts under Hopkins Hill Road appeared in good condition. The inlets to both culverts were partially clogged by aquatic vegetation, sticks, rock, and other debris. In all, approximately 12-inches of debris was blocking the bottom of each of the discharge culverts.

Photo No. 22. Spillway stilling basin and spillway culvert inlets. Note the vegetation and garbage choking the culvert intakes. Note the spall in the stilling basin left wall (arrow).

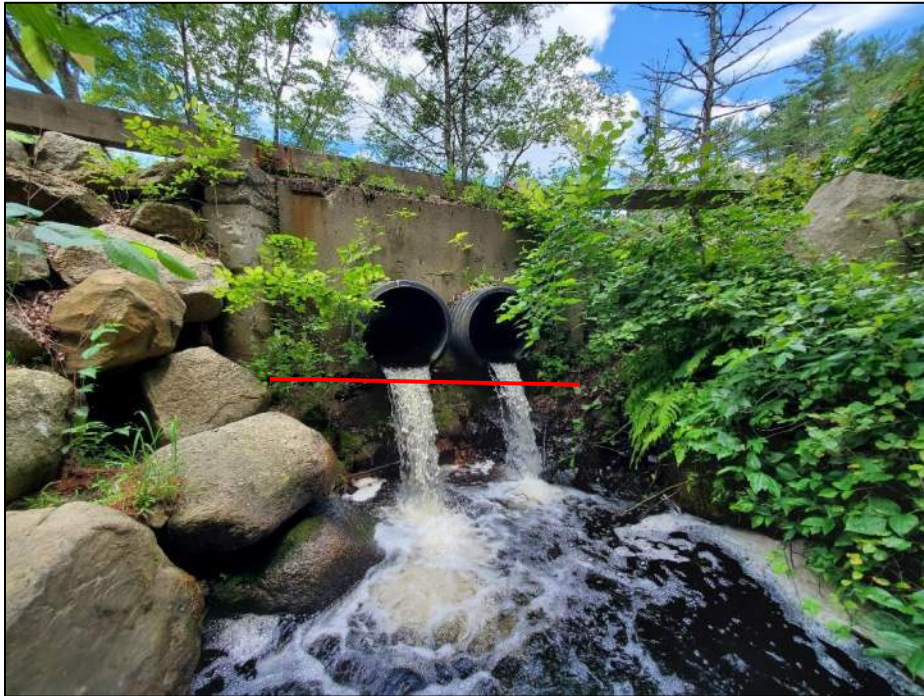
- While the concrete forming the downstream headwall appeared in good condition the ground surface below the headwall was beginning to undermine, resulting in about 2-3 inches of stone loss beneath the headwall.

Photo No. 23. Spillway culvert outlets. The red line indicates the bottom of the concrete headwall. Below this elevation the headwall is partially supported by stone, but is beginning to undermine.

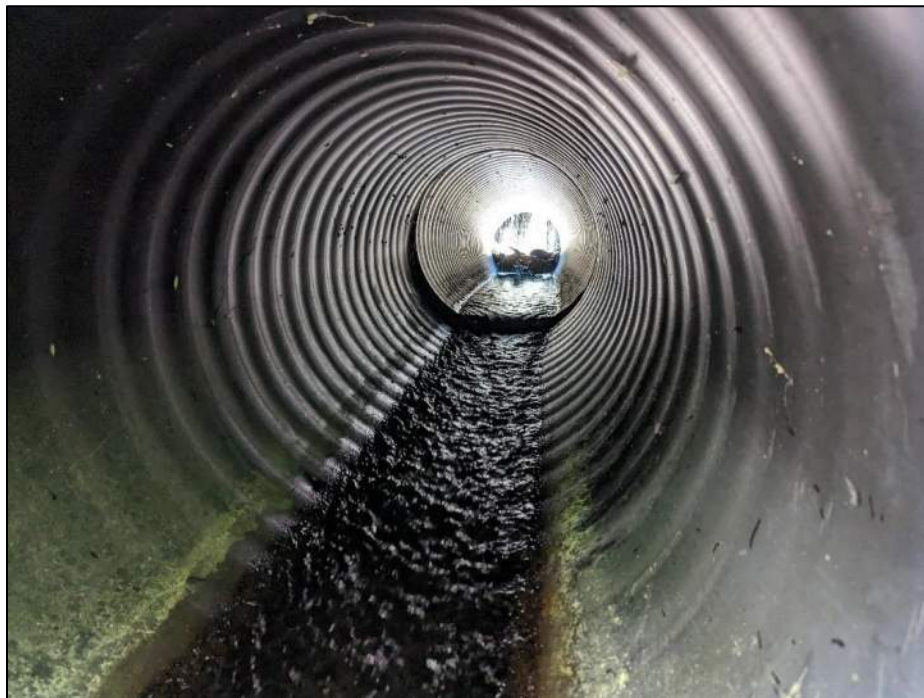
Photo No. 24. Interior of the left outlet pipe. Note the pipe is clear of debris, except for the entrance. Also note the displacement at the pipe joint midway up the pipe.

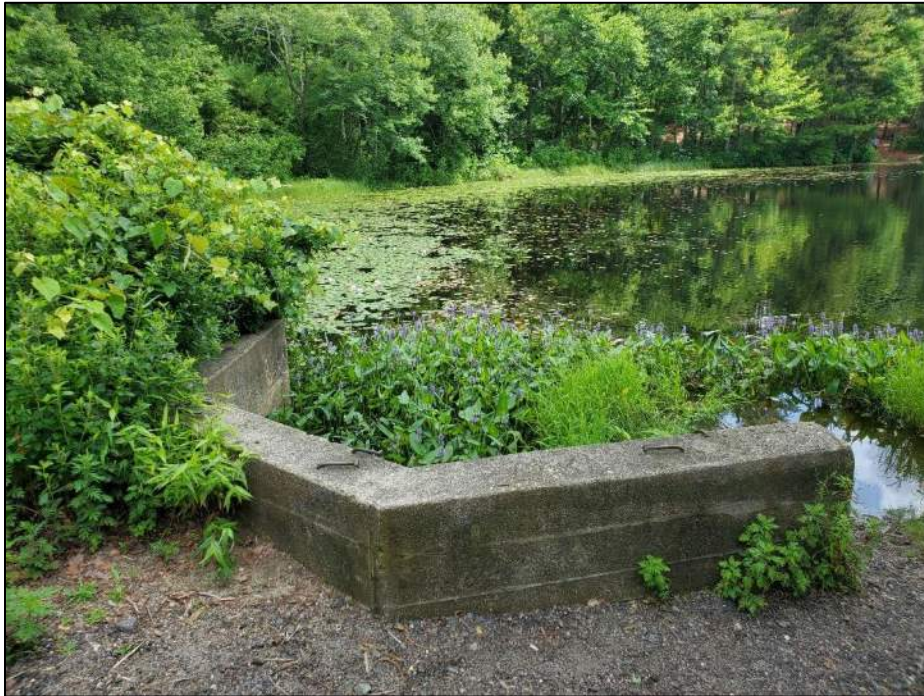
Photo No. 25. Historic LLO intake structure. Note the vegetation growing in the area of the historic intake.

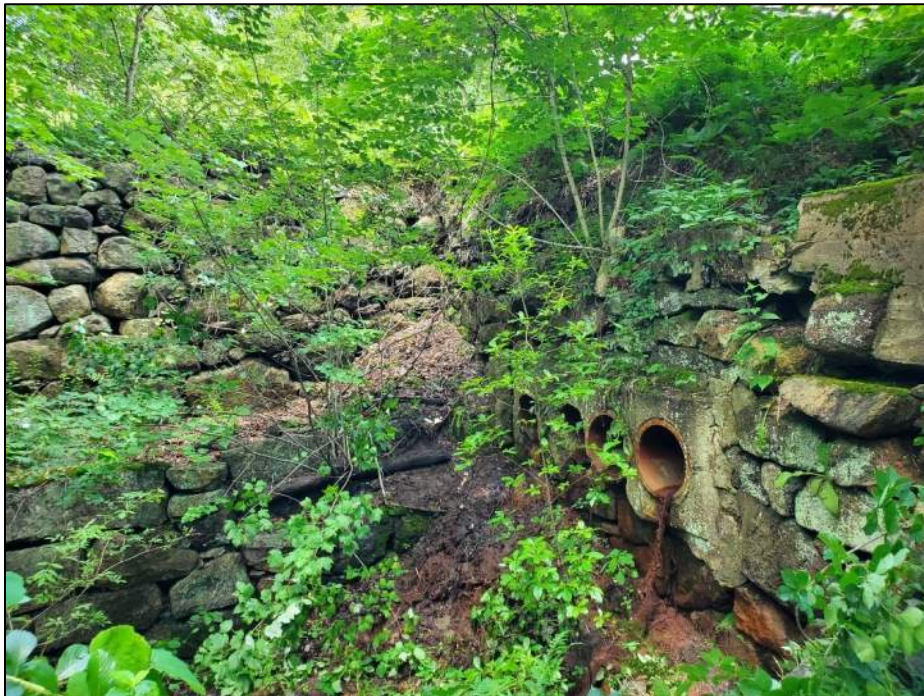
Photo No. 26. Historic LLO outlet structure. Note the woody brush growing through the headwall and downstream channel walls.

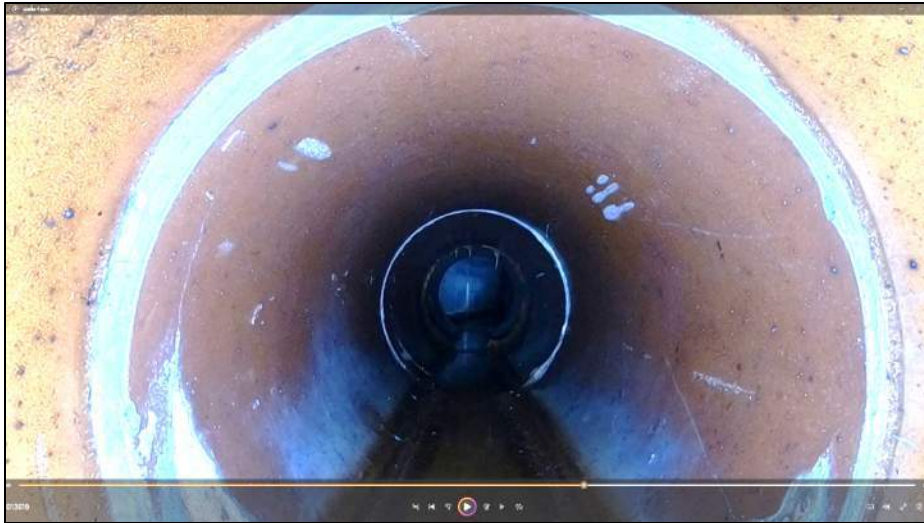
Photo No. 27. Interior of the vitrified clay LLO pipe approximately 40 feet upstream of the outlet as viewed during the conduit inspection. Note the apparent blockage at the end of the pipe.
